Manhole Inspection Summary

Manhole # S37SS_017MH

Insp Date: **12/21/06 11:07 AM**

Location Address: **431 WHITRIDGE AVE**

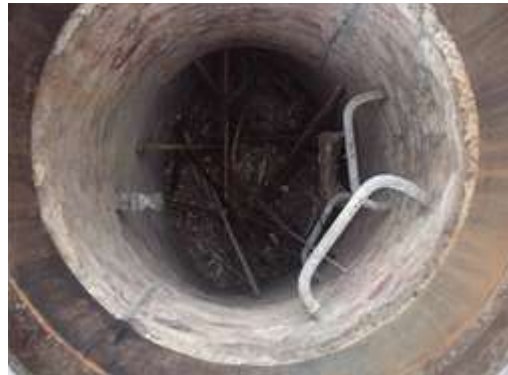
Top View

Channel debris.

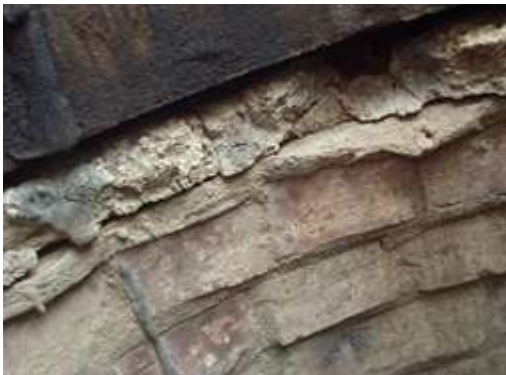
Defect

☒ **Leaks**

Condition: ☐ Sound ☐ Cracked ☐ Root Intrusion ☐ Loose Brick ☒ **Deteriorated**

Infiltration: ☐ None ☒ **Joint** ☐ Cracks ☐ Mortar ☐ Roots ☒ **Wall**

Frame leaks. Adjustment deterioration and infiltration.

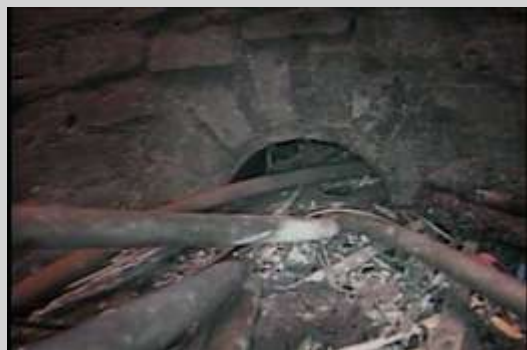
Pipe Out @ 12 O'Clock

Deposits: ☐ None ☒ **Mud** ☐ Sludge ☒ **Debris** ☐ Grease

Silt Depth: **7** (in.)

Deposits Extent: **Heavy**
